Manhole Inspection Summary

Manhole # S29Q__021MH

Location Address: **1204 Ridgley St**

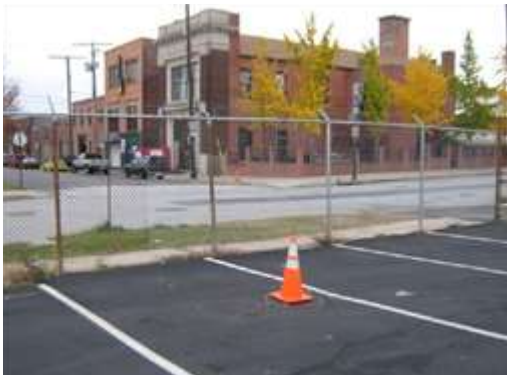
loc pic 3

parking lot across from 1204 Ridgely St

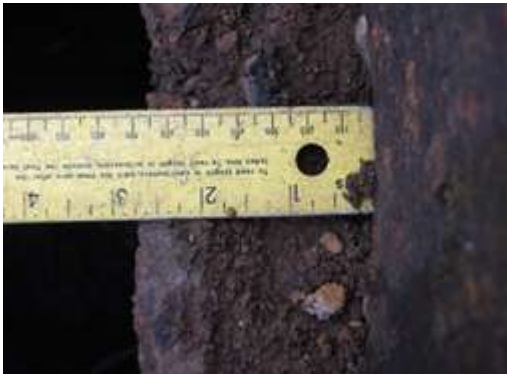
misc-5

frame offset 2.75" (pic2)

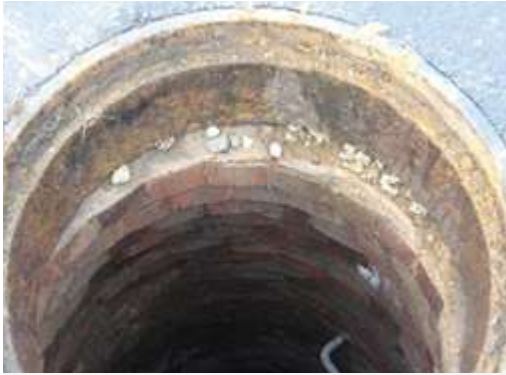
Defect 4

Frame Offset: **2.** (in.)
75

Frame offset

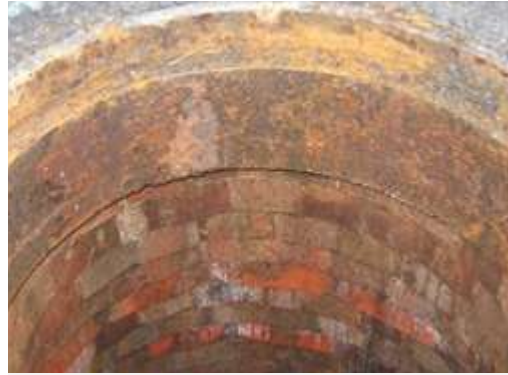
Defect 3

Condition: ☐ Sound ☐ Cracked ☒ **Leaks**

frame leaks

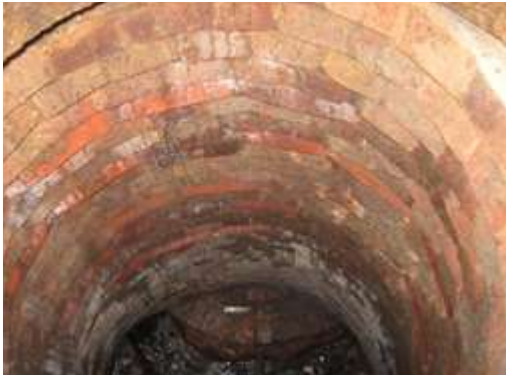
Defect 2

Infiltration: ☐ None ☐ Joint ☐ Cracks ☐ Mortar ☐ Roots ☒ **Wall**

infiltration from along chimney & corbel walls

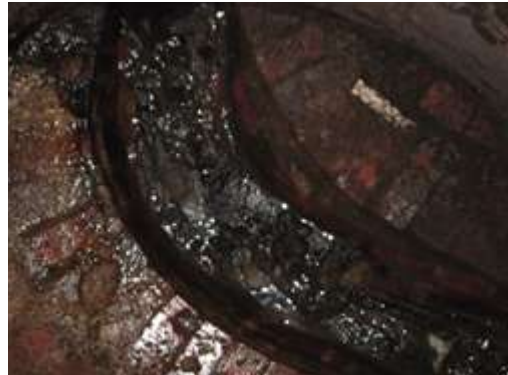
Defect 1

Condition: ☐ Sound ☐ Cracked ☐ Root Intrusion ☐ Deteriorated ☐ Leaks ☒ **Debris**

debris in channel

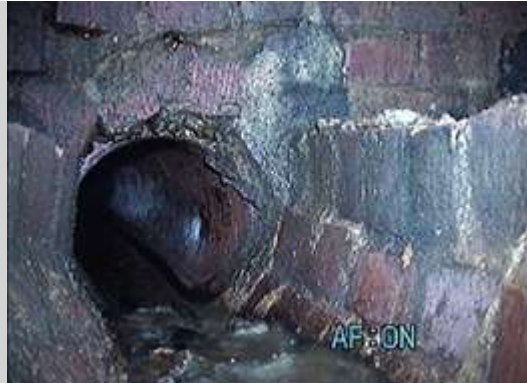
12 O'Clock Outflow

10 in. Circular Gravity Sewer
Pipe Out @ 12 O'Clock

Pipe Height: **10.8** (in.) Rod and Bar (Angled)
Pipe Material: **Clay** ☐ Pipe Lined
Invert Depth: **10.20** (ft.) Flow Characteristics: **Slow**
Deposits: ☐ None ☐ Mud ☒ **Sludge** ☒ **Debris** ☐ Grease
Silt Depth: **2** (in.) Deposits Extent: **Light**
Infiltration: **None** Pipe Seal Cond: **Sound**

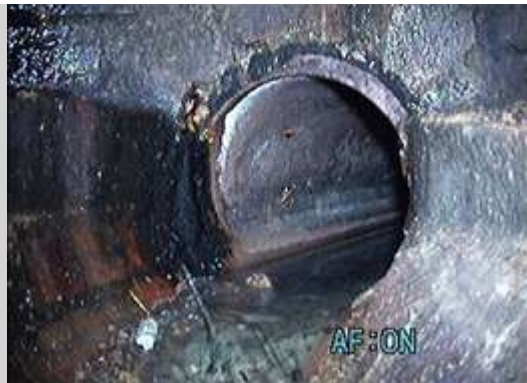
7 O'Clock Inflow

8 in. Circular Gravity Sewer
Pipe In @ 7 O'Clock

Pipe Height: **10.8** (in.) Rod and Bar (Angled)
Pipe Material: **Clay** ☐ Pipe Lined
Invert Depth: **9.97** (ft.) Flow Characteristics: **Slow**
Deposits: ☐ None ☐ Mud ☒ **Sludge** ☒ **Debris** ☐ Grease
Silt Depth: **2** (in.) Deposits Extent: **Light**
Infiltration: **None** Pipe Seal Cond: **Sound**
